Washington Metropolitan Area Transit Authority

Green Line Incident, Anacostia

## Arcing Insulator/Anacostia Station

Safety and Security Committee  
February 14, 2013

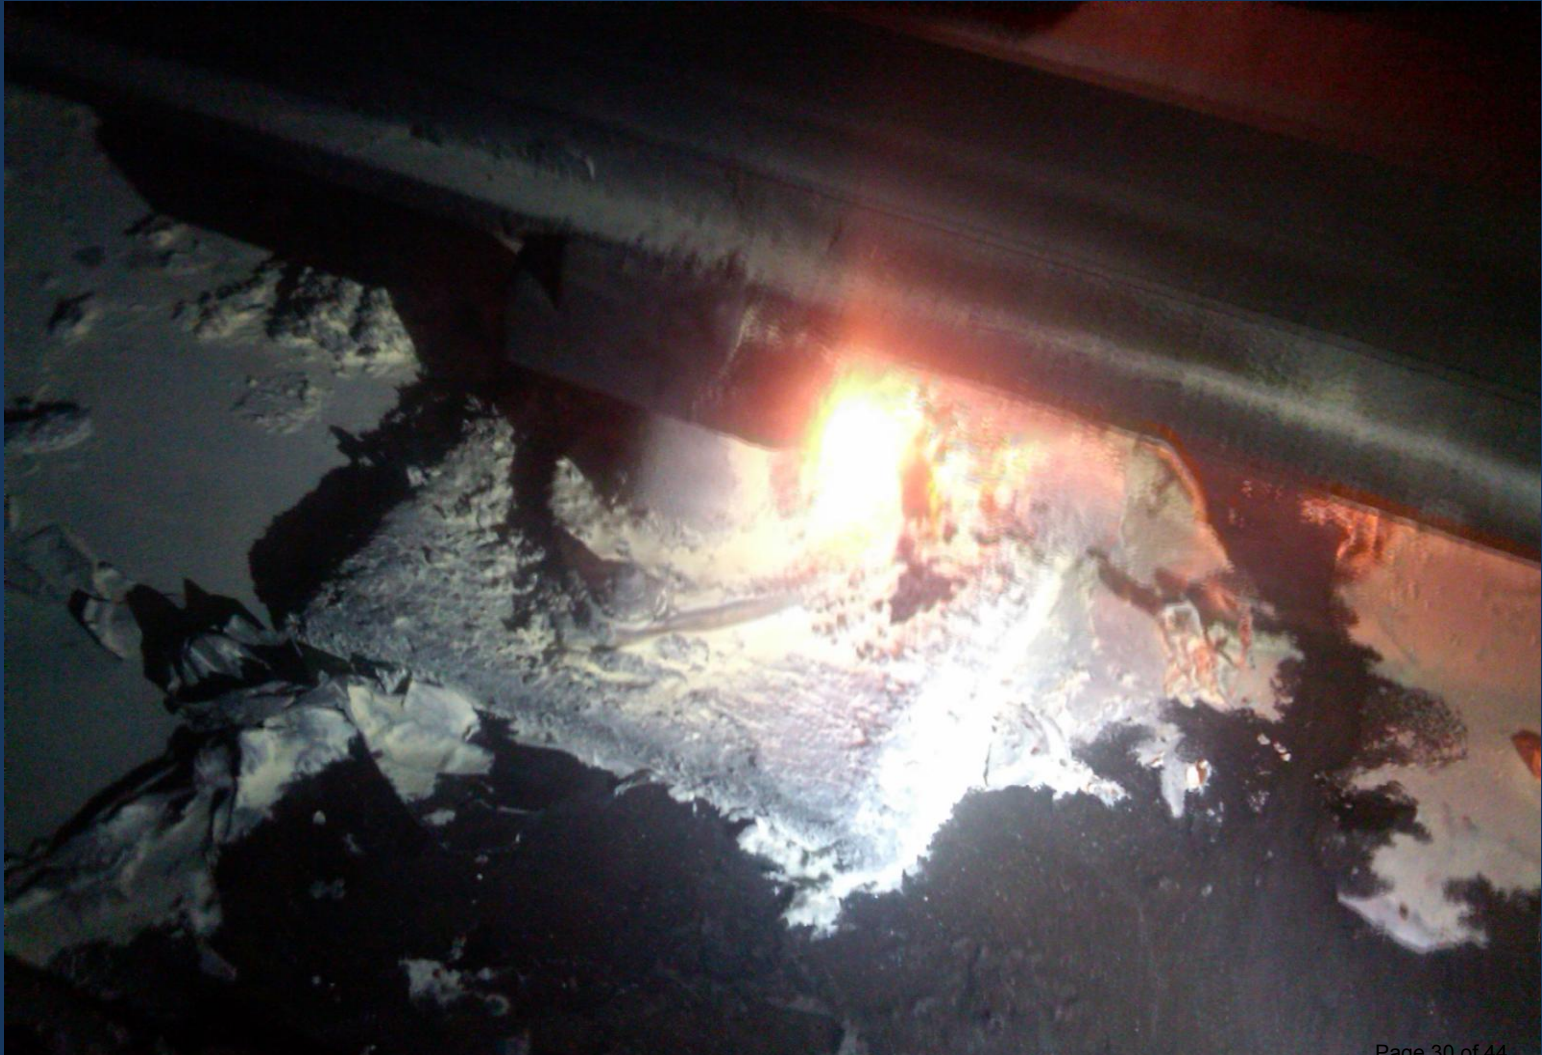
# Arcing Insulator (when a failure occurs)

There are more than 100,000 insulators systemwide and last year alone Metro replaced 11,059 insulators as part of the Capital Improvement Program. Yet arcing insulators occur about twice a month when electrical current arcs because an insulator fails to buffer it, thereby generating smoke. Metro's response to arcing insulators is usually a routine matter that requires track crews to remove the insulator.

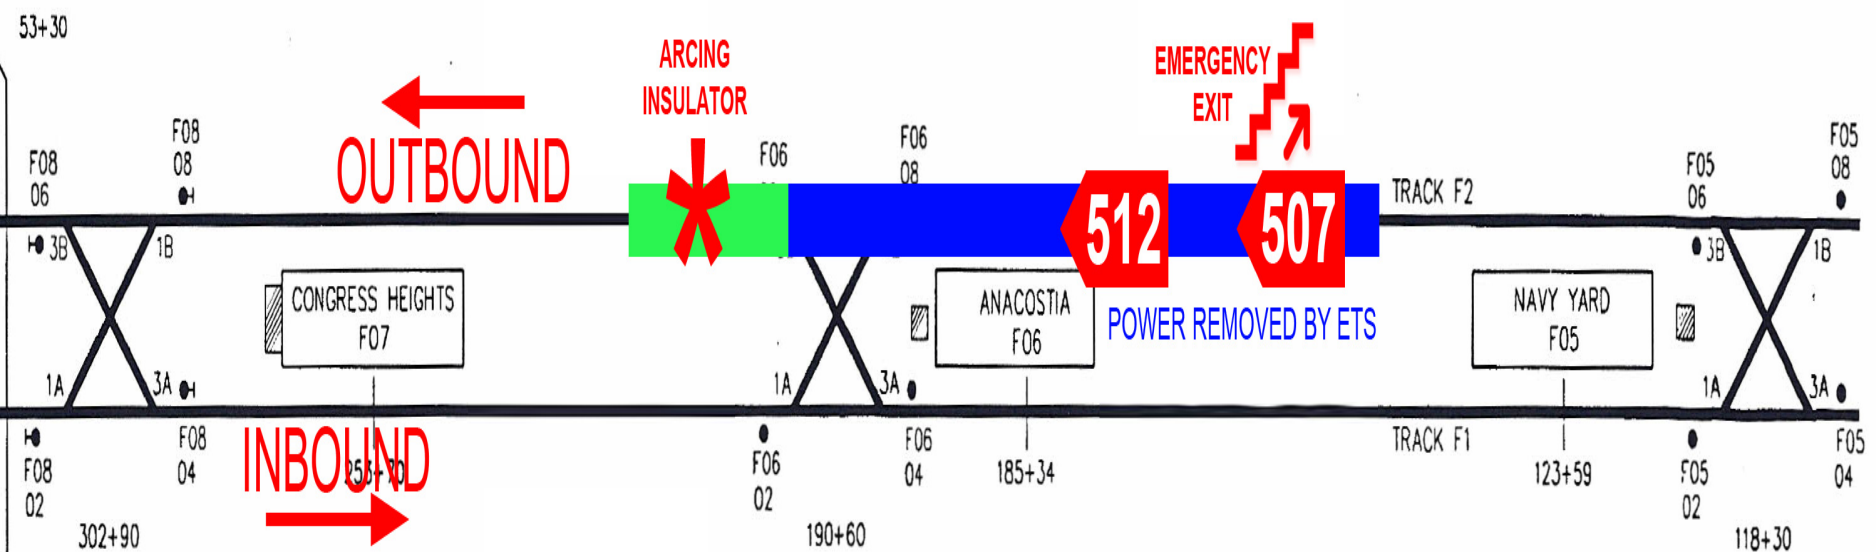
# Incident Diagram

Trains #512 and #507 began moving toward Anacostia in the outbound direction. Due to a miscommunication between transit police on the scene and the transit police liaison in the rail control center, police on the platform at Anacostia were unaware of the planned train route around the area where the crew was working. When MTPD personnel observed train lights approaching on track 2, they believed there was an immediate life safety threat to the people repairing the insulator. MTPD activated the ETS in the second instance to remove 3rd rail power on track 2. That caused trains #512 and #507 to each come to a safe stop on rail without power. In both cases, emergency lighting remain on and public address systems were working.

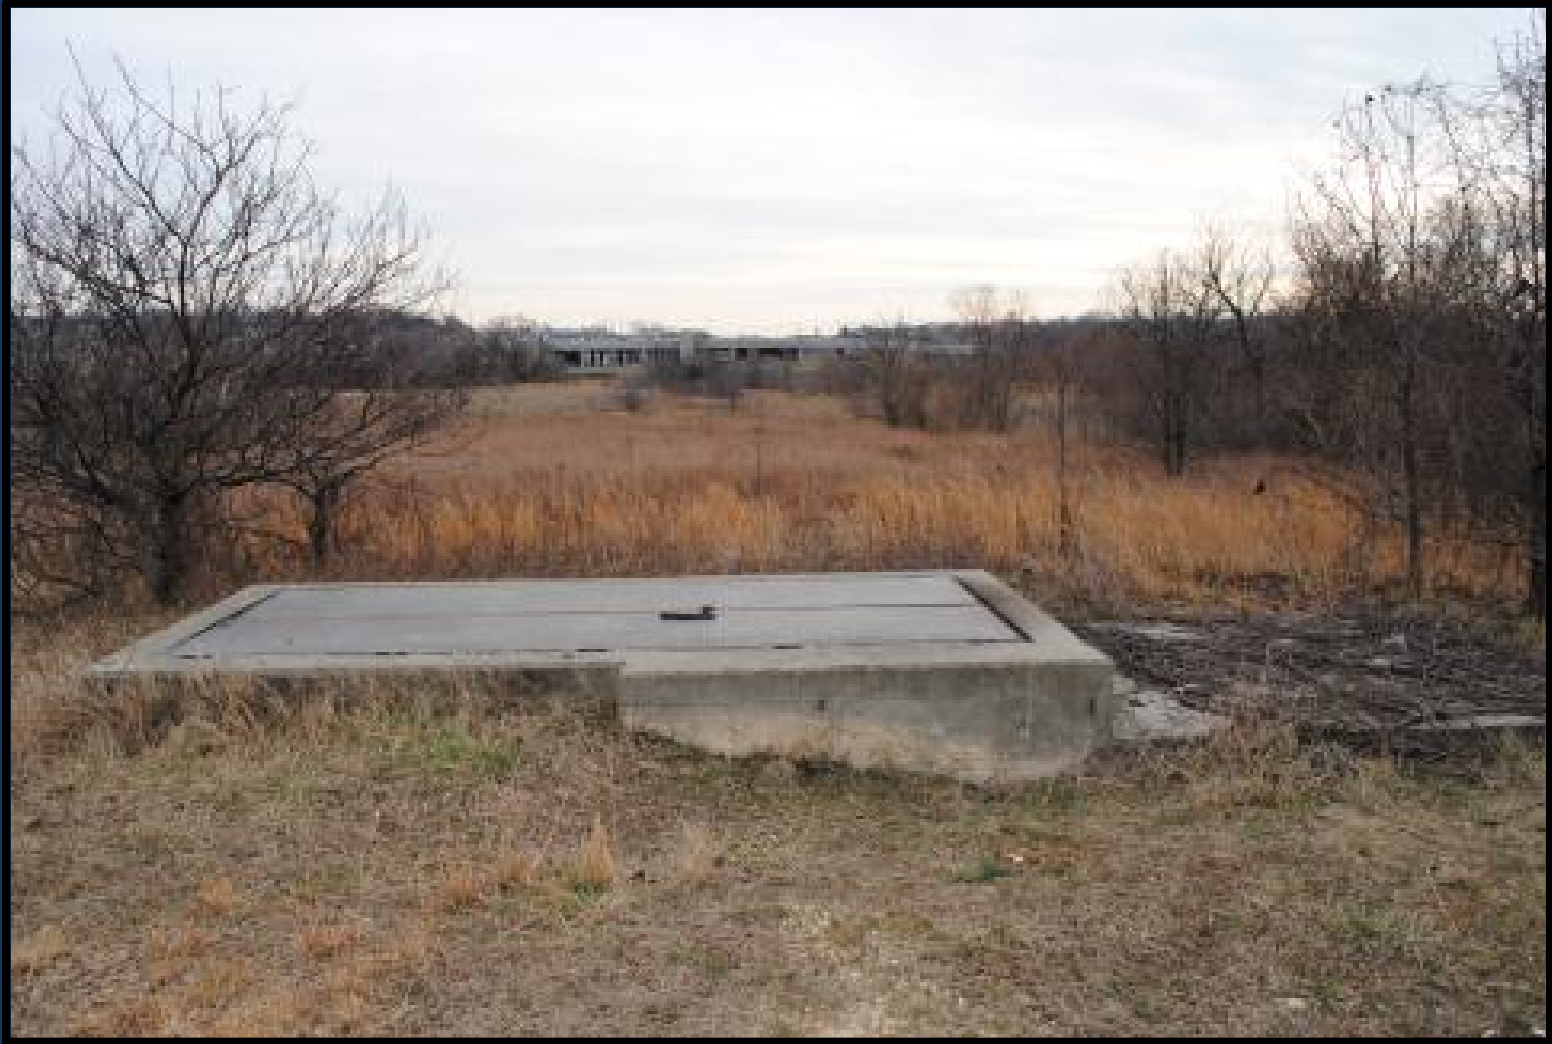
# Exit Shaft During Incident

- Passenger self evacuation created an immediate life/safety hazard and prolonged the delay for other customers
- Lack of capability to isolate radio communications with incident trains
- Insufficient buses available to accommodate demand
- Due to staging of emergency equipment at Anacostia, not able to effectively manage shuttle bus operation
- Shuttle bus operation was not effectively established at Navy Yard
